**Flood Control Project Maintenance  
Levee Inspections**

**Fall 2019 Levee Maintenance Deficiency Summary Report**

**Sacramento River Basin**

**Reclamation District No. 2035 Conaway**

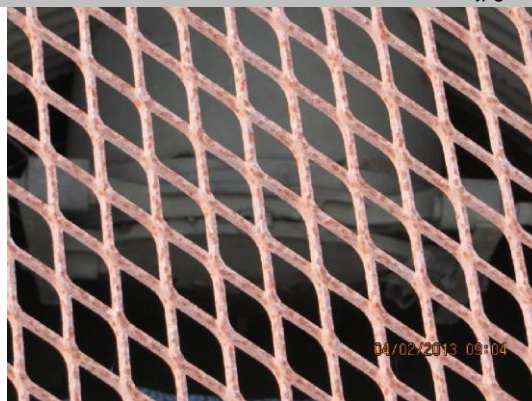
Photo 1 of 3 : UCIP\_FA\_2019\_56045\_18102.jpg

Comment Code						
Inspector Comment						
DS_ID:17819 FS_ID:56045 EP_NO: 4363 Repair Type: Non-Urgent Crossing Status: Found UCIP Comments: 08/16/2019 Pending update... record will be updated in 2020. (O. Magana - DWR UCIP)04/02/2013 This pipe appears abandoned and if so should be done so properly. (W. Wylie - DWR UCIP) FIELD_STRUCT_DESC: *ABANDONED* 36-inch corrugated metal drainage pipe through the levee, 7.8 feet below the crown. 30-inch welded steel pipe sleeved through the 36-inch corrugated metal pipe (CMP) with annular space grouted. Flap gate in 72-inch corrugated metal pipe (CMP) riser at the waterside (WS) toe with abandoned pump platform on the south side of East Main Street. (30-inch drainage pipe sleeved through 36-inch conductor pipe through the railway embankment authorized under Permit No. 4363, 1963 - City of Woodland, City Engineer). [Additional Reference(s): DWR Levee Log, 1990]. FS Date: 8/16/2019 12:16:00 PM

Flap gate and pipe at bottom of 72-inch CMP riser on WS toe.

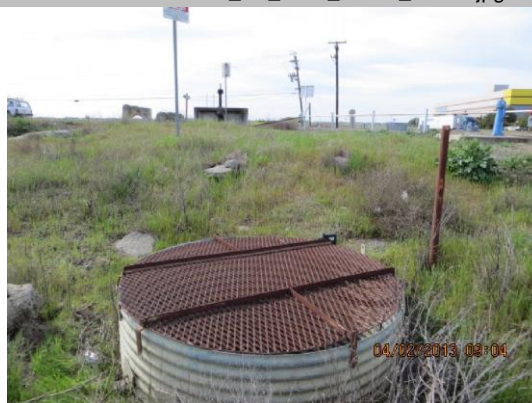
Photo 2 of 3 : UCIP\_FA\_2019\_56045\_18101.jpg

72-inch CMP riser on WS toe.

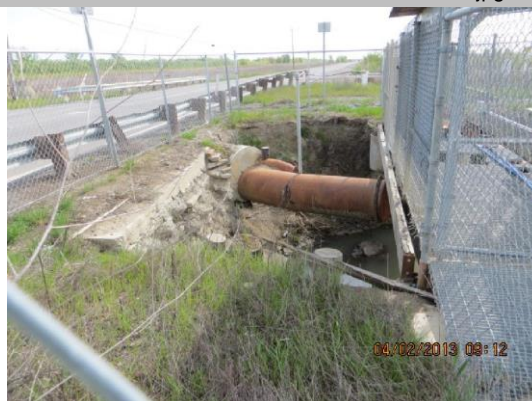
Photo 3 of 3 : UCIP\_FA\_2019\_56045\_18100.jpg

Comment Code						
Inspector Comment						
DS_ID:17819 FS_ID:56045 EP_NO: 4363 Repair Type: Non-Urgent Crossing Status: Found UCIP Comments: 08/16/2019 Pending update... record will be updated in 2020. (O. Magana - DWR UCIP)04/02/2013 This pipe appears abandoned and if so should be done so properly. (W. Wylie - DWR UCIP) FIELD_STRUCT_DESC: *ABANDONED* 36-inch corrugated metal drainage pipe through the levee, 7.8 feet below the crown. 30-inch welded steel pipe sleeved through the 36-inch corrugated metal pipe (CMP) with annular space grouted. Flap gate in 72-inch corrugated metal pipe (CMP) riser at the waterside (WS) toe with abandoned pump platform on the south side of East Main Street. (30-inch drainage pipe sleeved through 36-inch conductor pipe through the railway embankment authorized under Permit No. 4363, 1963 - City of Woodland, City Engineer). [Additional Reference(s): DWR Levee Log, 1990]. FS Date: 8/16/2019 12:16:00 PM

Pipe with 30-inch grouted at 200-feet LS of toe.

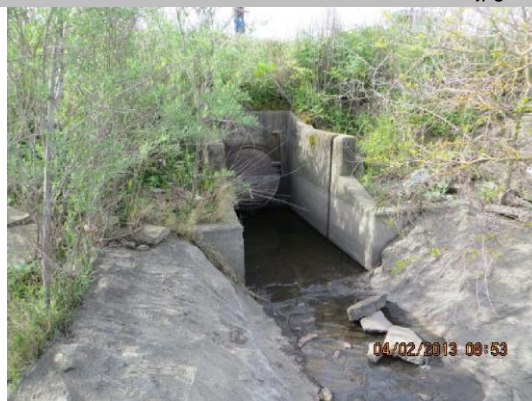
Photo 1 of 3 : UCIP\_FA\_2019\_56049\_18109.jpg

Comment Code						
Inspector Comment						
DS_ID:17814 FS_ID:56049 EP_NO: 10127 Repair Type: No Action Needed Crossing Status: Found UCIP Comments: 08/16/2019 Pending update... record will be updated in 2020. (O. Magana - DWR UCIP) FIELD_STRUCT_DESC: 42-inch concrete encased corrugated metal drainage pipe through the levee, 10 feet below the crown. Flap gate on the waterside (WS) end. Grouted spillway on the WS. Pipe exposed on the landside (LS). (36-inch pipe [HLM 0.02] authorized under Automatic Board Order (ABO) issued as Permit No. 10127, 1974 - City of Woodland, Department of Public Works). [Additional Reference(s): DWR Levee Log, 1990. USACE Sacramento O&M Manual 126, November 1961, (HLM 0.01), listed as 5.5 feet below the crown]. FS Date: 8/16/2019 12:20:00 PM

Flap gate and spillway on WS toe.

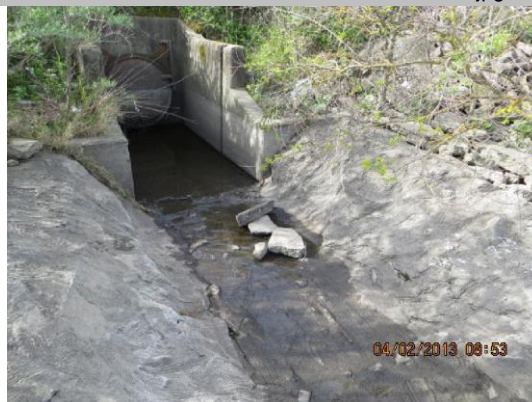
Photo 2 of 3 : UCIP\_FA\_2019\_56049\_18108.jpg

Flap gate and spillway on WS toe.

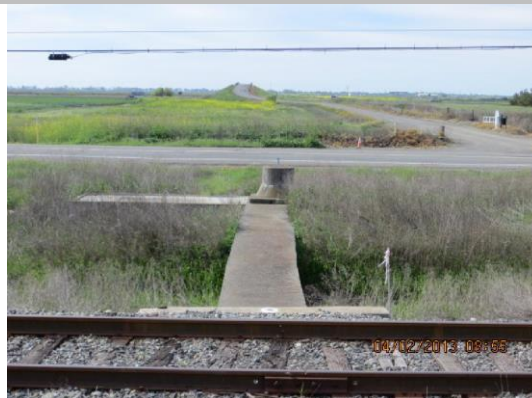
Photo 3 of 3 : UCIP\_FA\_2019\_56049\_18107.jpg

Concrete encased pipe on LS toe.

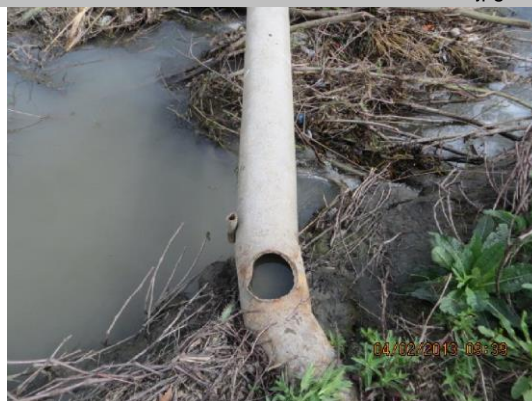
Photo 1 of 3 : UCIP\_FA\_2019\_56056\_18115.jpg

Comment Code					
Inspector Comment					
DS_ID:17816 FS_ID:56056 EP_NO: 12597 Repair Type: Non-Urgent Crossing Status: Found UCIP Comments: 08/16/2019 Pending update... record will be updated in 2020. (O. Magana - DWR UCIP)04/02/2013 Pipe appears abandoned and if so should be done so properly. (W. Wylie - DWR UCIP) FIELD_STRUCT_DESC: *ABANDONED* 18-inch steel conductor pipe for floating silt dredge through the levee, 3.4 feet below the crown. 10-inch steel pipe sleeved through the 18-inch steel conductor pipe with annular space grouted. Siphon breaker on the waterside (WS) shoulder in steel riser. (18-inch conductor pipe installed under the railroad fill by boring and 10-inch pipe sleeved through conductor pipe authorized under Permit No. 12597, 1978 - Reclamation District No. 2035). [Additional Reference(s): DWR Levee Log, 1990]. FS Date: 8/16/2019 12:20:00 PM

Exposed pipe at WS toe/stream.

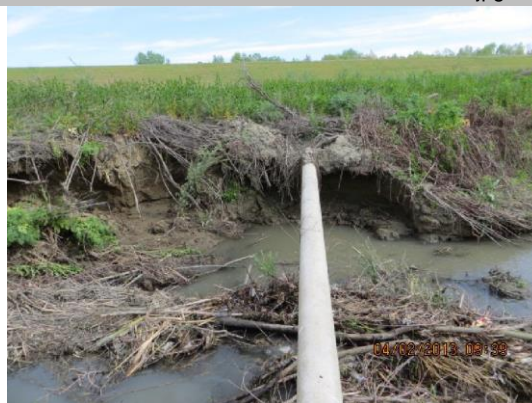
Photo 2 of 3 : UCIP\_FA\_2019\_56056\_18114.jpg

Exposed pipe at WS toe/stream.

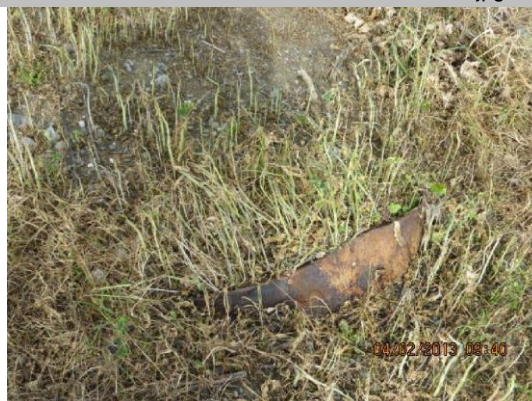
Photo 3 of 3 : UCIP\_FA\_2019\_56056\_18113.jpg

Buried steel riser on WS shoulder

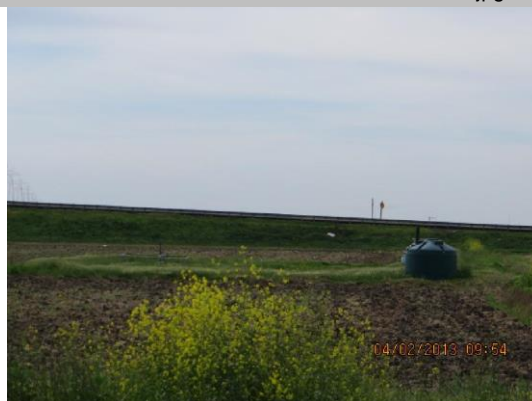
Photo 1 of 2 : UCIP\_FA\_2019\_56059\_18188.jpg

Comment Code					
Inspector Comment					
DS_ID:17867 FS_ID:56059 EP_NO: 13201 Repair Type: Non-Urgent Crossing Status: Indicator Found UCIP Comments: 08/16/2019 Pending update... record will be updated in 2020. (O. Magana - DWR UCIP)04/02/2013 Pipe needs to be properly marked or abandoned. (W. Wylie - DWR UCIP) FIELD_STRUCT_DESC: 8-inch casing of an unknown material through the levee, 25 feet below the crown. 3-inch gas line sleeved through the casing with annular space filled with bentonite. Possible vent for pipe on the landside (LS) next to Old River Road. (3-inch gas pipeline within an 8-inch casing authorized under Permit No. 13201, 1981 - Pacific Gas and Electric Company [PG&E]). FS Date: 8/16/2019 12:21:00 PM

Natural gas well on south side of Old river road.

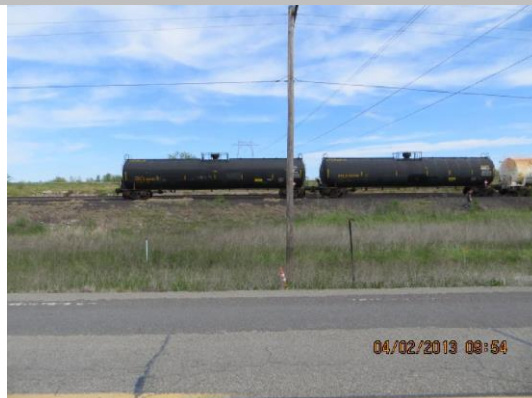
Photo 2 of 2 : UCIP\_FA\_2019\_56059\_18187.jpg

Vent pipe to right of JP next to Old River Road.

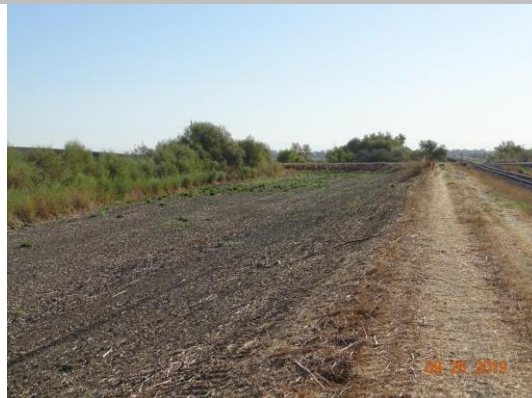
Photo 1 of 1 : FA\_2019\_RD2035\_238\_9\_20190926\_00013.jpg

View of the maintained waterside slope. Fall 2019.

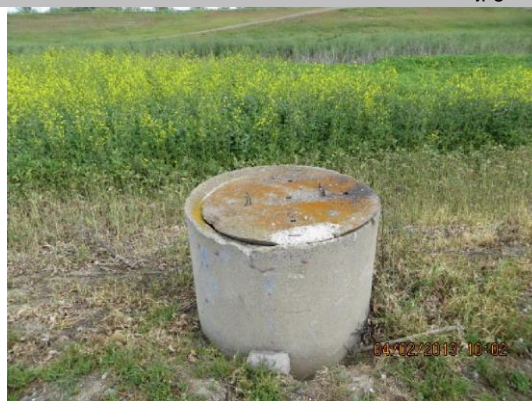
Photo 1 of 1 : UCIP\_FA\_2019\_56060\_18189.jpg

Comment Code						
Inspector Comment						
DS_ID:17817						
FS_ID:56060						
EP_NO: 2544						
Repair Type: Non-Urgent						
Crossing Status: Found						
UCIP Comments: 08/16/2019 Pending update... record will be updated in 2020. (O. Magana - DWR UCIP)04/02/2013 Pipe appears to be abandoned as there is no pumphouse. Needs to be abandoned properly (W. Wylie - DWR UCIP)						
FIELD_STRUCT_DESC: 16-inch steel sewage discharge pipe through the levee, 5 feet below the crown. Pump on piling structure in drainage ditch on the landside (LS). 36-inch concrete standpipe on the waterside (WS) shoulder. (16-inch sewage discharge pipe authorized under Permit No. 2544, 1957 - City of Woodland). [Additional Reference(s): DWR Levee Log, 1990].						
FS Date: 8/16/2019 12:21:00 PM

36-inch Concrete stand pipe on WS shoulder.

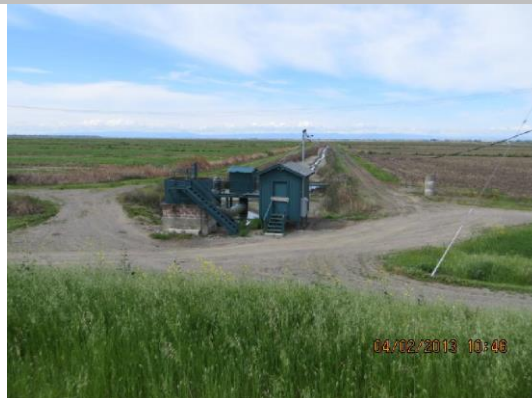
Photo 1 of 3 : UCIP\_FA\_2019\_56053\_18202.jpg

Comment Code					
Inspector Comment					
DS_ID:17822 FS_ID:56053 EP_NO: N/A Repair Type: Urgent Crossing Status: Found UCIP Comments: 08/16/2019 Pending update... record will be updated in 2020. (O. Magana - DWR UCIP)10/30/2018 Same as last inspection. Flap gate on the WS was submerged at the time of the inspection. Erosion is still present behind the headwall. Sink hole/burrow activity was observed along the concrete box located on the LS. Recommend internal inspection of the pipe section through levee to determine the condition of the pipe through the levee. Crossing remains Urgent due to signs of pipe leakage on LS. (O. Magana - DWR UCIP)09/14/2016 - Flap gate on the WS was submerged at time of inspection. LS headwall at the pumping plant has exposed rebar. There is still erosion present behind the headwall. However, water was present making it difficult to determine if it is getting worse. As-built drawings were requested from LMA consultant representative. (T. Hatch/UCIP)04/02/2013 - Flap gate broken in half on WS toe. Some erosion at headwalls on pumping plant. (W. Wylie/UCIP) FIELD_STRUCT_DESC: 44-inch corrugated metal drainage pipe through the levee, 22 feet below the crown. Pump on platform in drainage ditch at the landside (LS) toe. Slide gate and flap gates in a 5-foot by 9-foot concrete box. Flap gate on the waterside (WS) toe. 8-inch vent/standpipe at the WS toe. [Additional Reference(s): DWR Levee Log, 1990. USACE Sacramento O&M Manual 121, May 1959, (HLM 0.4) (4-foot by 4-foot concrete culvert listed)]. FS Date: 8/16/2019 12:25:00 PM

Pumping plant off LS toe.

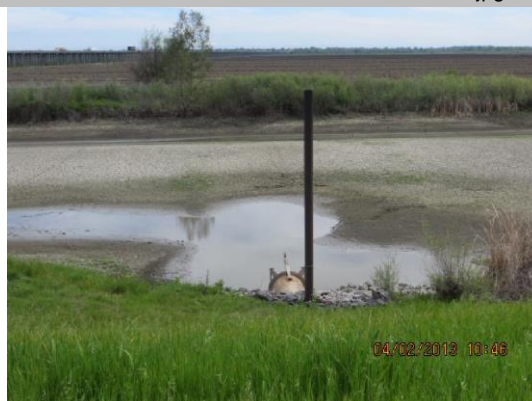
Photo 2 of 3 : UCIP\_FA\_2019\_56053\_18201.jpg

Pipe and flap gate with vent riser on WS toe.

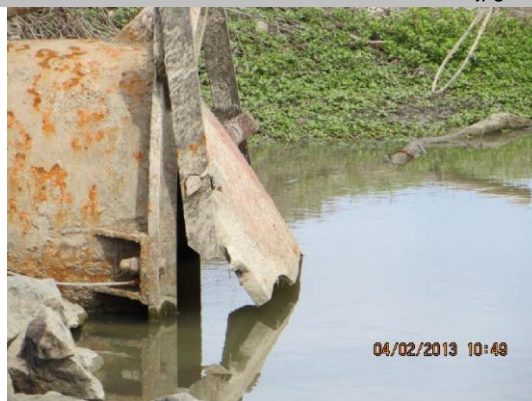
Photo 3 of 3 : UCIP\_FA\_2019\_56053\_18200.jpg

Comment Code						
Inspector Comment						
DS_ID:17822 FS_ID:56053 EP_NO: N/A Repair Type: Urgent Crossing Status: Found UCIP Comments: 08/16/2019 Pending update... record will be updated in 2020. (O. Magana - DWR UCIP)10/30/2018 Same as last inspection. Flap gate on the WS was submerged at the time of the inspection. Erosion is still present behind the headwall. Sink hole/burrow activity was observed along the concrete box located on the LS. Recommend internal inspection of the pipe section through levee to determine the condition of the pipe through the levee. Crossing remains Urgent due to signs of pipe leakage on LS. (O. Magana - DWR UCIP)09/14/2016 - Flap gate on the WS was submerged at time of inspection. LS headwall at the pumping plant has exposed rebar. There is still erosion present behind the headwall. However, water was present making it difficult to determine if it is getting worse. As-built drawings were requested from LMA consultant representative. (T. Hatch/UCIP)04/02/2013 - Flap gate broken in half on WS toe. Some erosion at headwalls on pumping plant. (W. Wylie/UCIP) FIELD_STRUCT_DESC: 44-inch corrugated metal drainage pipe through the levee, 22 feet below the crown. Pump on platform in drainage ditch at the landside (LS) toe. Slide gate and flap gates in a 5-foot by 9-foot concrete box. Flap gate on the waterside (WS) toe. 8-inch vent/standpipe at the WS toe. [Additional Reference(s): DWR Levee Log, 1990. USACE Sacramento O&M Manual 121, May 1959, (HLM 0.4) (4-foot by 4-foot concrete culvert listed)]. FS Date: 8/16/2019 12:25:00 PM

Broken flap gate at WS toe.

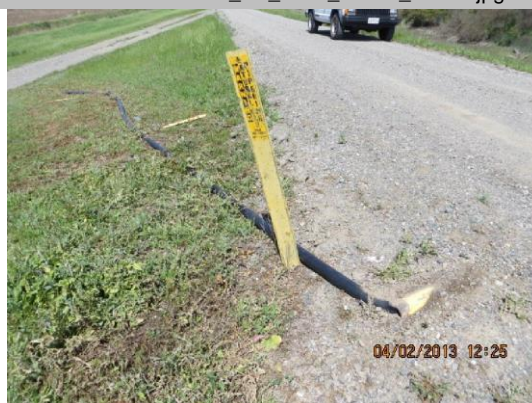
Photo 1 of 3 : UCIP\_FA\_2019\_56057\_18922.jpg

Comment Code						
Inspector Comment						
DS_ID:22956 FS_ID:56057 EP_NO: N/A Repair Type: Non-Urgent Crossing Status: Found UCIP Comments: 08/16/2019 Pending update... record will be updated in 2020. (O. Magana - DWR UCIP)09/14/2016 - Pipe has been removed from the levee and the levee has been repaired. It is unknown if these repairs were done with a permit or if the fill was properly compacted. Gas line markers still on WS shoulder of levee. It is unknown if another gas line exists in this location. (T. Hatch/UCIP)04/02/2013 - Pipe does not have appropriate cover and is marked as gas line. Does not appear to be a permitted utility. (W. Wylie/UCIP) FIELD_STRUCT_DESC: *REMOVED* 4-inch steel pipe of an unknown purpose through the levee, 3 inches below the crown. 2-inch polyvinyl chloride (PVC) pipe sleeved through the 4-inch steel pipe. No other appurtenances found. Markers along alignment indicate that the pipe may be a gas line. FS Date: 8/16/2019 12:26:00 PM

Pipe crossing with gasline marker on LS shoulder.

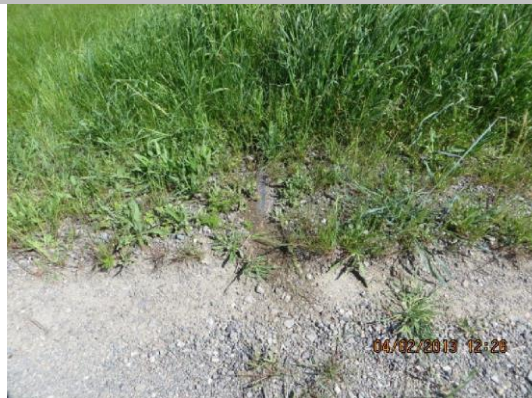
Photo 2 of 3 : UCIP\_FA\_2019\_56057\_18921.jpg

Pipe on WS shoulder.

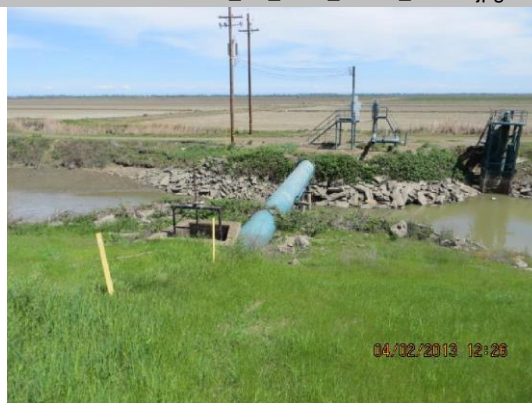
Photo 3 of 3 : UCIP\_FA\_2019\_56057\_18920.jpg

Pipe with gasline markers on WS slope.

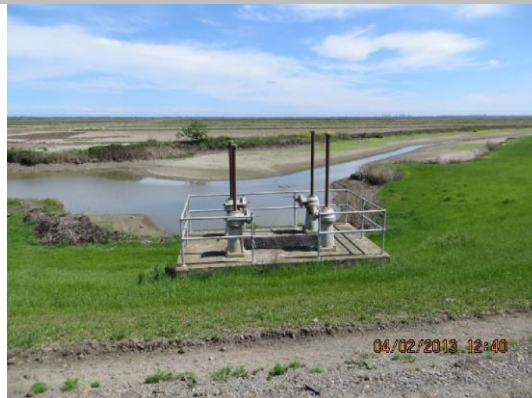
Photo 1 of 3 : UCIP\_FA\_2019\_10933\_18226.jpg

LM Start	2.15	Rating **	A/W	Issue No.	982	
LM End	2.15	Issue Type +	Ma	Location *		
Category	Supplemental			GPS Latitude/Longitude		
				Start	End	
Item	DRAFT DWR UCIP LMA Responsibility			38.646445°	38.646445°	
				-121.666423°	-121.666423°	
DWR ID	17833					
Comment Code						
Inspector Comment						
DS_ID:17833						
FS_ID:10933						
EP_NO: N/A						
Repair Type: No Action Needed						
Crossing Status: Found						
UCIP Comments:						
FIELD_STRUCT_DESC: 1 of 2: 60-inch drainage pipe of an unknown material through the levee, 26 feet below the crown. Concrete well and gate structure on the waterside (WS) slope. [Additional Reference(s): DWR Levee Log, 1990. USACE Sacramento O&M Manual 121, May 1959, (HLM 2.3) (6-foot by 6-foot concrete culvert listed)].						
FS Date: 4/2/2013

Slide gates in concrete vault on WS slope.

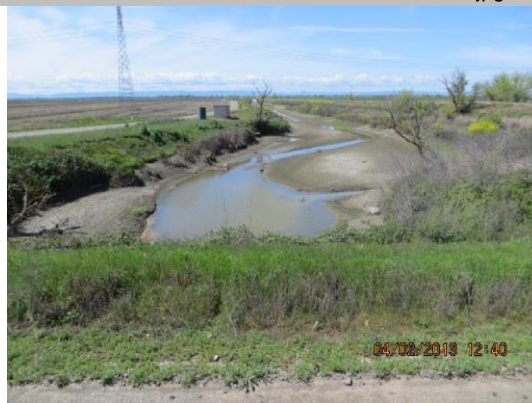
Photo 2 of 3 : UCIP\_FA\_2019\_10933\_18225.jpg

LS at intake.

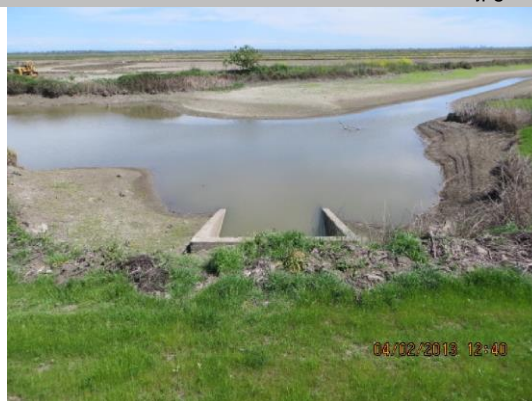
Photo 3 of 3 : UCIP\_FA\_2019\_10933\_18224.jpg

Outlet on WS toe.

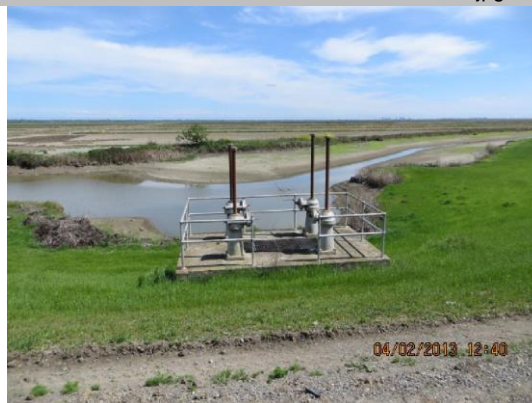
Photo 1 of 3 : UCIP\_FA\_2019\_10934\_18230.jpg

LM Start	2.15	Rating **	A/W	Issue No.	983	
LM End	2.15	Issue Type +	Ma	Location *		
Category	Supplemental			GPS Latitude/Longitude		
				Start		End
Item	DRAFT DWR UCIP LMA Responsibility			38.646425 °		38.646425 °
				-121.666421 °		-121.666421 °
DWR ID	17877					
Comment Code						
Inspector Comment						
DS_ID:17877						
FS_ID:10934						
EP_NO: N/A						
Repair Type: No Action Needed						
Crossing Status: Found						
UCIP Comments:						
FIELD_STRUCT_DESC: 2 of 2: 60-inch drainage pipe of an unknown material through the levee, 26 feet below the crown. Concrete well and gate structure on the waterside (WS) slope. Concrete headwalls on both ends. [Additional Reference(s): DWR Levee Log, 1990. USACE Sacramento O&M Manual 121, May 1959, (HLM 2.3) (6-foot by 6-foot concrete culvert listed)].						
FS Date: 4/2/2013

Slide gates in concrete vault on WS slope.

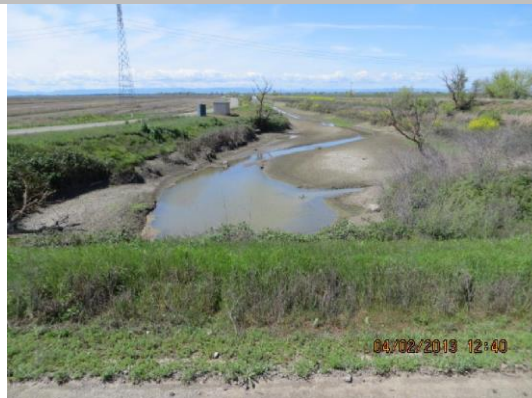
Photo 2 of 3 : UCIP\_FA\_2019\_10934\_18229.jpg

Intake at channel on LS toe.

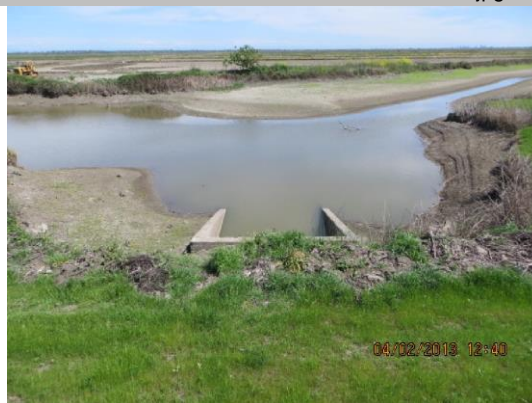
Photo 3 of 3 : UCIP\_FA\_2019\_10934\_18228.jpg

Concrete headwall on WS toe.

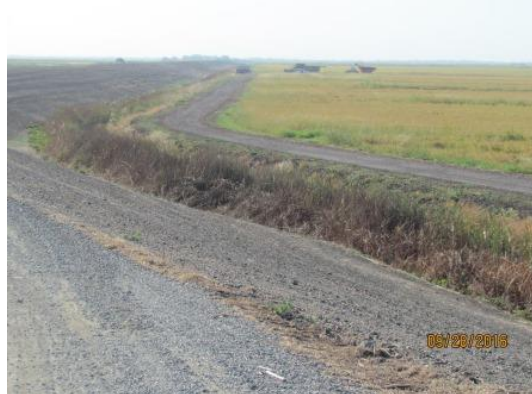
Photo 1 of 1 : FA\_2019\_RD2035\_239\_979\_20190829\_00006.jpg

View of the ditch on the landward side of the levee looking downstream.  
Fall 2016.

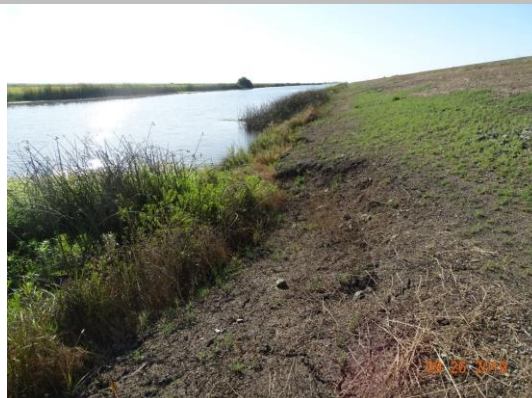
Photo 1 of 1 : FA\_2019\_RD2035\_239\_9\_20190926\_00028.jpg

LM Start	2.91	Rating **	M	Issue No.	9
LM End	2.91	Issue Type +	Ma	Location *	WS
Category	Earthen Levee			GPS Latitude/Longitude	
				Start	End
Item	Erosion / Bank Caving			38.637048 °	38.637048 °
				-121.659227 °	-121.659227 °
DWR ID	DWR_RD2035_02_f_2019_9				
Comment Code					
E2 : Schedule repair of erosion site prior to the next inspection.					
Inspector Comment					
Appears to be a 15' wide section of bank caving near the waterside toe. Recommend repairing.

View of bank caving on the waterside slope. Fall 2019.

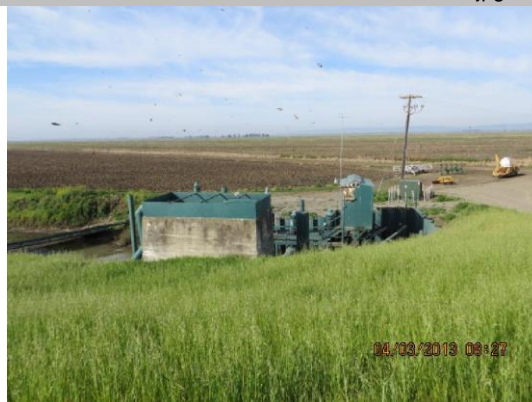
Photo 1 of 3 : UCIP\_FA\_2019\_11526\_18935.jpg

Comment Code					
Inspector Comment					
DS_ID:17828 FS_ID:11526 EP_NO: 1701 Repair Type: Non-Urgent Crossing Status: Found UCIP Comments: 04/03/2013 Animal activity at outlet causing damage to berm and undermining the pipe at the outlet headwall on WS toe. (W. Wylie - DWR UCIP) FIELD_STRUCT_DESC: 60-inch corrugated metal drainage pipe encased in 6 inches of reinforced concrete through the levee, 20.6 feet below the crown. Slide gate in a 7-foot-diameter corrugated metal pipe (CMP) riser on the waterside (WS) slope. Pumping plant with 6 pumps and pipes that discharge into a 4-foot by 18-foot surge box on the landside (LS) toe. (drainage pumping plant, 60-inch pipe, authorized under Permit No. 1701, 1952 - Reclamation District No. 2035). [Additional Reference(s): DWR Levee Log, 1990. USACE Sacramento O&M Manual 121, May 1959, (HLM 4.7)]. FS Date: 4/3/2013

Surge box and pumping plant on LS toe.

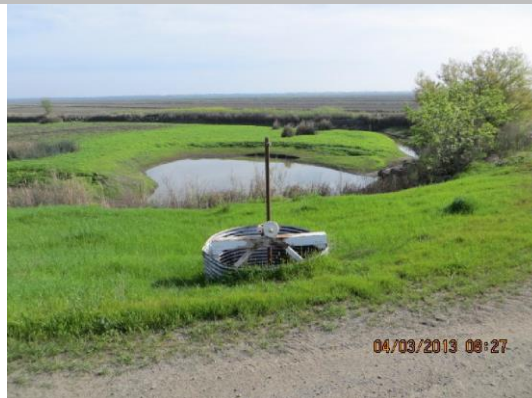
Photo 2 of 3 : UCIP\_FA\_2019\_11526\_18934.jpg

7-foot diameter CMP riser and slide gate on WS slope.

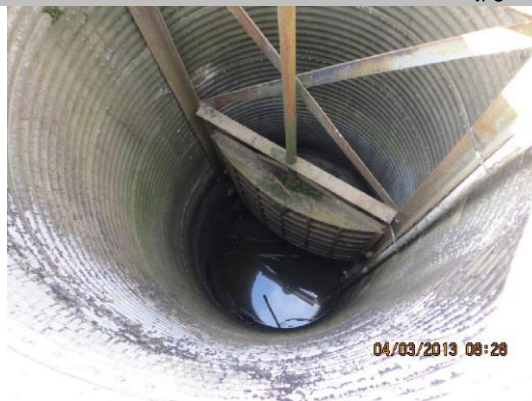
Photo 3 of 3 : UCIP\_FA\_2019\_11526\_18933.jpg

7-foot diameter CMP riser and slide gate on WS slope.

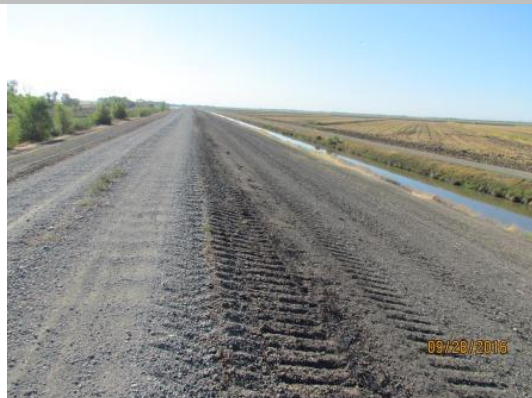
Photo 1 of 1 : FA\_2019\_RD2035\_239\_10\_20190829\_00001.jpg

View of the drainage ditch on the landward side of the levee looking downstream. Fall 2016.

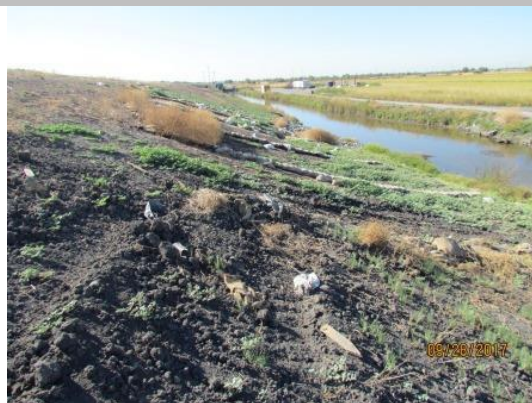
Photo 1 of 4 : FA\_2019\_RD2035\_239\_31\_20190829\_00002.jpg

View of the damaged landside slope. Fall 2017.

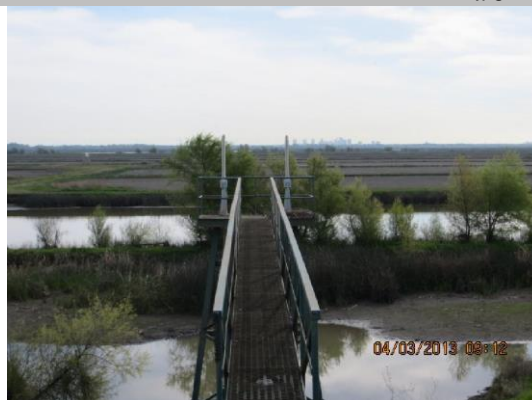
Photo 1 of 3 : UCIP\_FA\_2019\_50089\_18327.jpg

LM Start	6.50	Rating **	M	Issue No.	986
LM End	6.50	Issue Type +	En	Location *	
Category	Supplemental			GPS Latitude/Longitude	
				Start	End
Item	DRAFT DWR UCIP Field Study			38.590691 °	38.590691 °
				-121.631284 °	-121.631284 °
DWR ID	17868

Steel walkway to slide gates on WS shoulder.

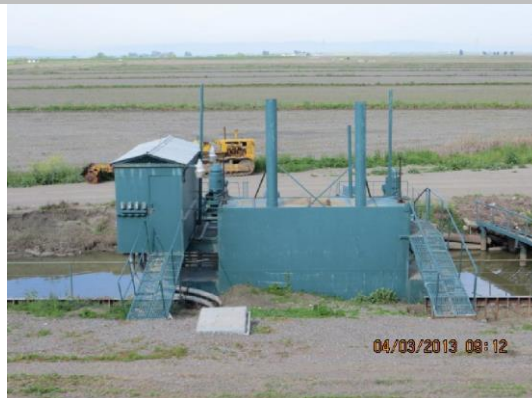
Photo 2 of 3 : UCIP\_FA\_2019\_50089\_18326.jpg

Pumping plant on LS toe.

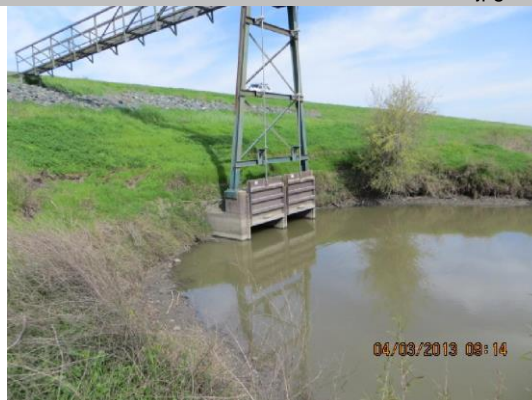
Photo 3 of 3 : UCIP\_FA\_2019\_50089\_18325.jpg

Slide gates at WS toe.

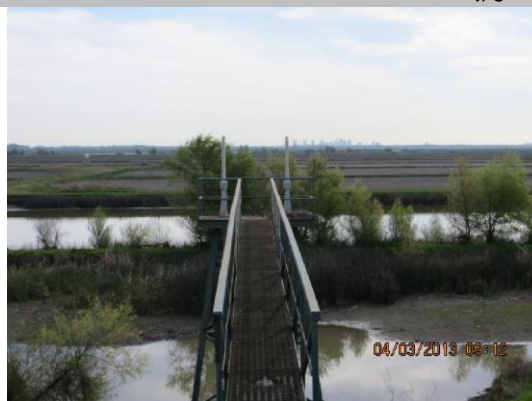
Photo 1 of 3 : UCIP\_FA\_2019\_50088\_18321.jpg

Steel walkway to Slide gate handles on WS shoulder.

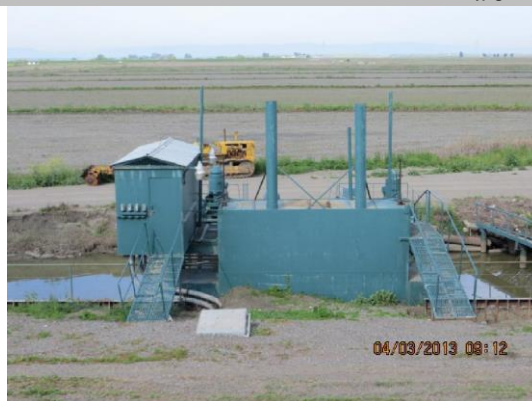
Photo 2 of 3 : UCIP\_FA\_2019\_50088\_18320.jpg

Surge box and pumping plant on LS toe.

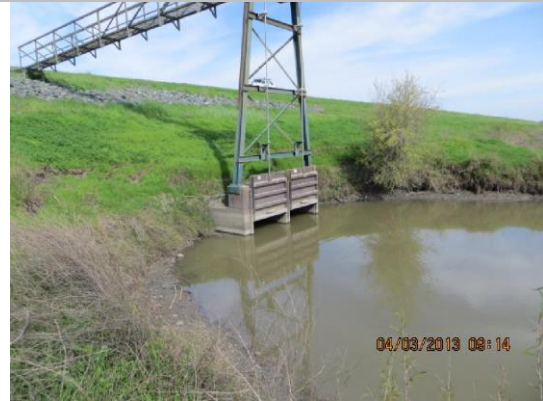
Photo 3 of 3 : UCIP\_FA\_2019\_50088\_18319.jpg

Slide gates at outlet on WS toe.

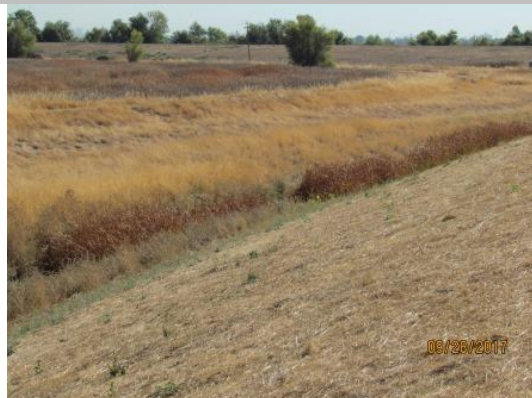
Photo 1 of 1 : FA\_2019\_RD2035\_240\_973\_20190829\_00003.jpg

View looking downstream of the landside ditch at the levee toe. Fall 2017.

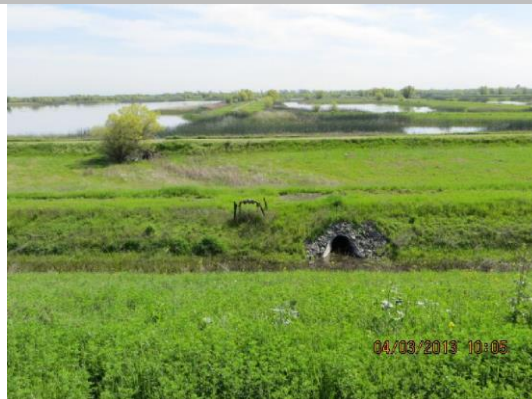
Photo 1 of 3 : UCIP\_FA\_2019\_53430\_18345.jpg

Gasline vent off LS toe.

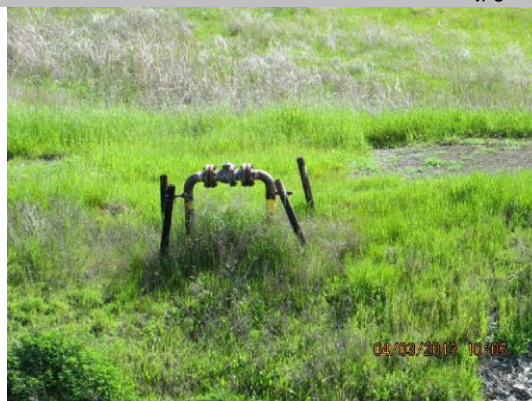
Photo 2 of 3 : UCIP\_FA\_2019\_53430\_18344.jpg

Gasline vent off LS toe.

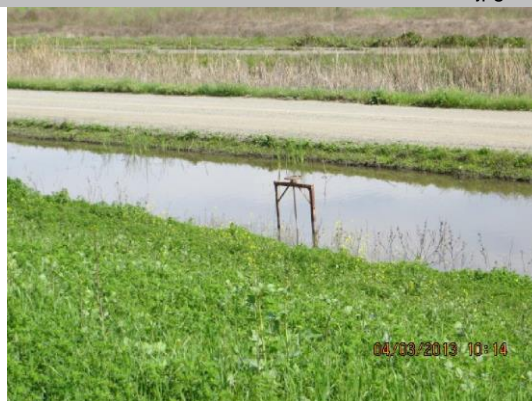
Photo 1 of 3 : UCIP\_FA\_2019\_41128\_18348.jpg

Slide gate and headwall in canal at LS toe.

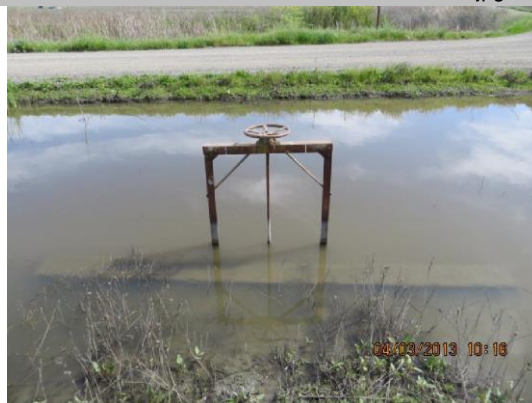
Photo 2 of 3 : UCIP\_FA\_2019\_41128\_18347.jpg

Slide gate and headwall in canal at LS toe.

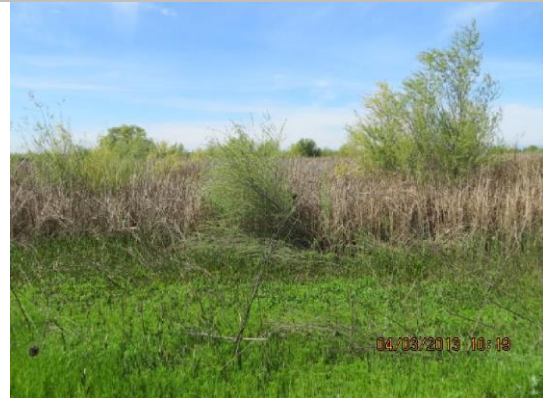
Photo 3 of 3 : UCIP\_FA\_2019\_41128\_18346.jpg

Vegetated area blocks access to WS of pipe.

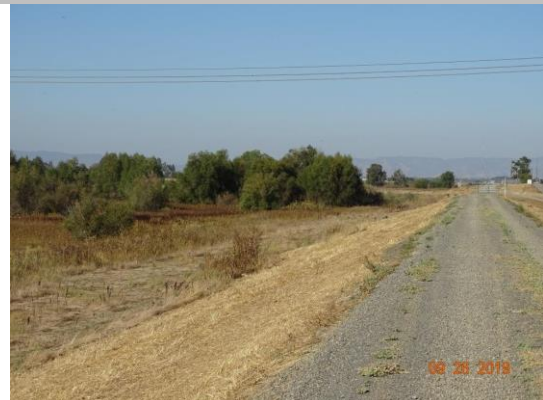
Photo 1 of 1 : FA\_2019\_RD2035\_240\_6\_20190926\_00015.jpg

View of the maintained landside slope. Fall 2019.

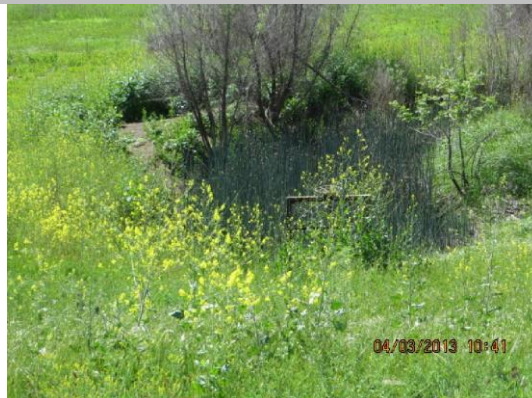
Photo 1 of 2 : UCIP\_FA\_2019\_11011\_18354.jpg

Slide gate at WS toe showing excessive vegetation.

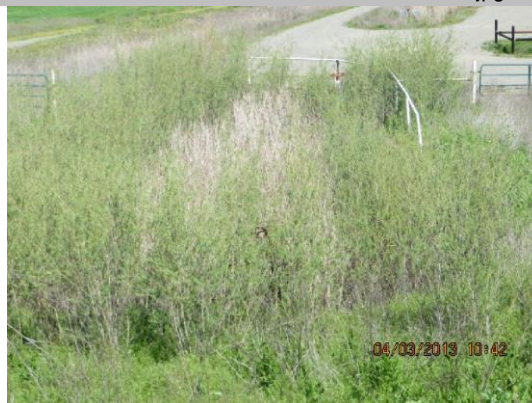
Photo 2 of 2 : UCIP\_FA\_2019\_11011\_18353.jpg

Slide gate at LS toe showing excessive vegetation.

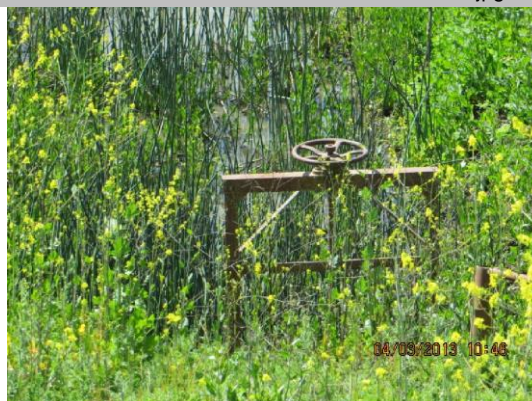
Photo 1 of 3 : UCIP\_FA\_2019\_11012\_18357.jpg

Combination flap and slide gate on WS toe. With excessive vegetation

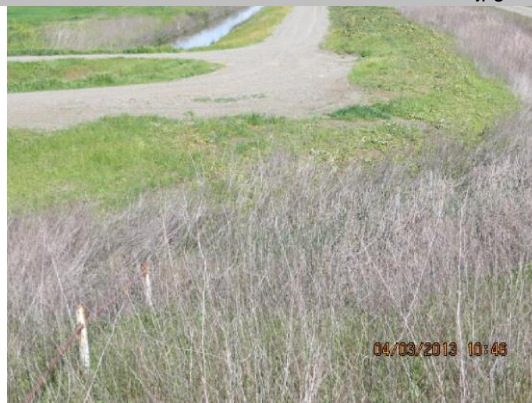
Photo 2 of 3 : UCIP\_FA\_2019\_11012\_18356.jpg

Headwall at bottom of fenceline on LS toe

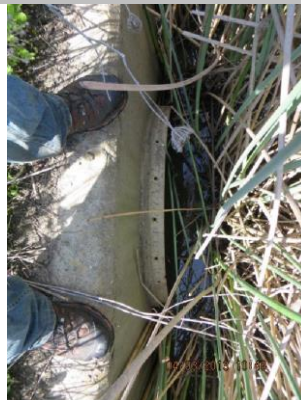
Photo 3 of 3 : UCIP\_FA\_2019\_11012\_18355.jpg

Headwall and pipe on LS toe.

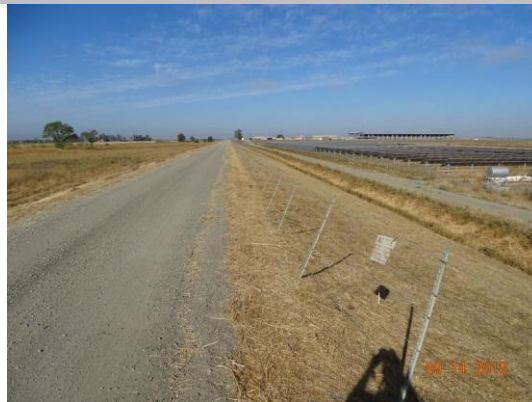
Photo 1 of 1 : FA\_2019\_RD2035\_240\_5\_20190829\_00001.jpg

View of fence on the landside shoulder of the crown. Fall 2018.
